EVT 8-89

EVALUATION OF PREFABRICATED ALUMINUM DUNNAGE IN A RAIL AND ROAD TRANSPORTATION ENVIRONMENT

EVALUATION DIVISION SAVANNA, ILLINOIS 61074-9639

US ARMY DEFENSE AMMUNITION CENTER AND SCHOOL

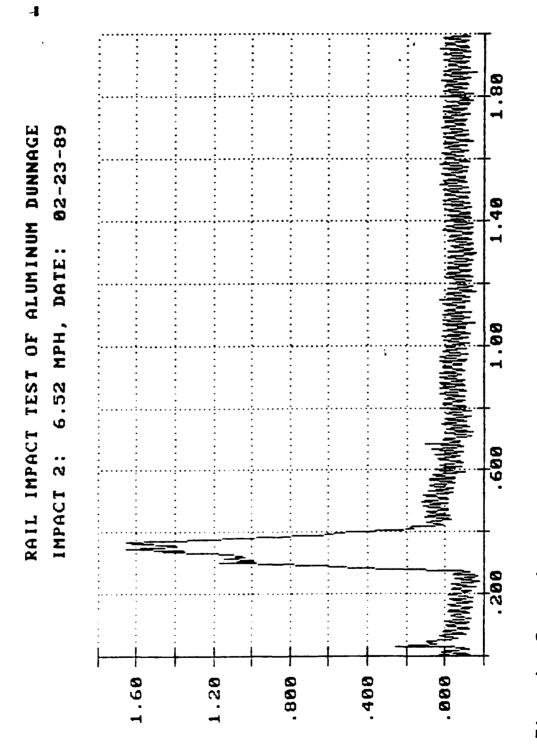
IMPACT NO.	END STRUCK	VELOCITY (MPH)	IMPACT FORCE	REMARKS
1	forward	4.12	194,000	no damage
2	forward	6.52	165,000	no damage
3	forward	8.31	379,000	Exceeded structural limit of end gate. Aluminum angle deformed and corner weld broken.
